**COVE RIVER BASIN  
WEST HAVEN, CONNECTICUT**

**UPPER LAKE PHIPPS  
DAM NO.1 - CT 00109  
DAM NO.2 - CT 00110**

**PHASE I INSPECTION REPORT  
NATIONAL DAM INSPECTION PROGRAM**

**JULY 1980**

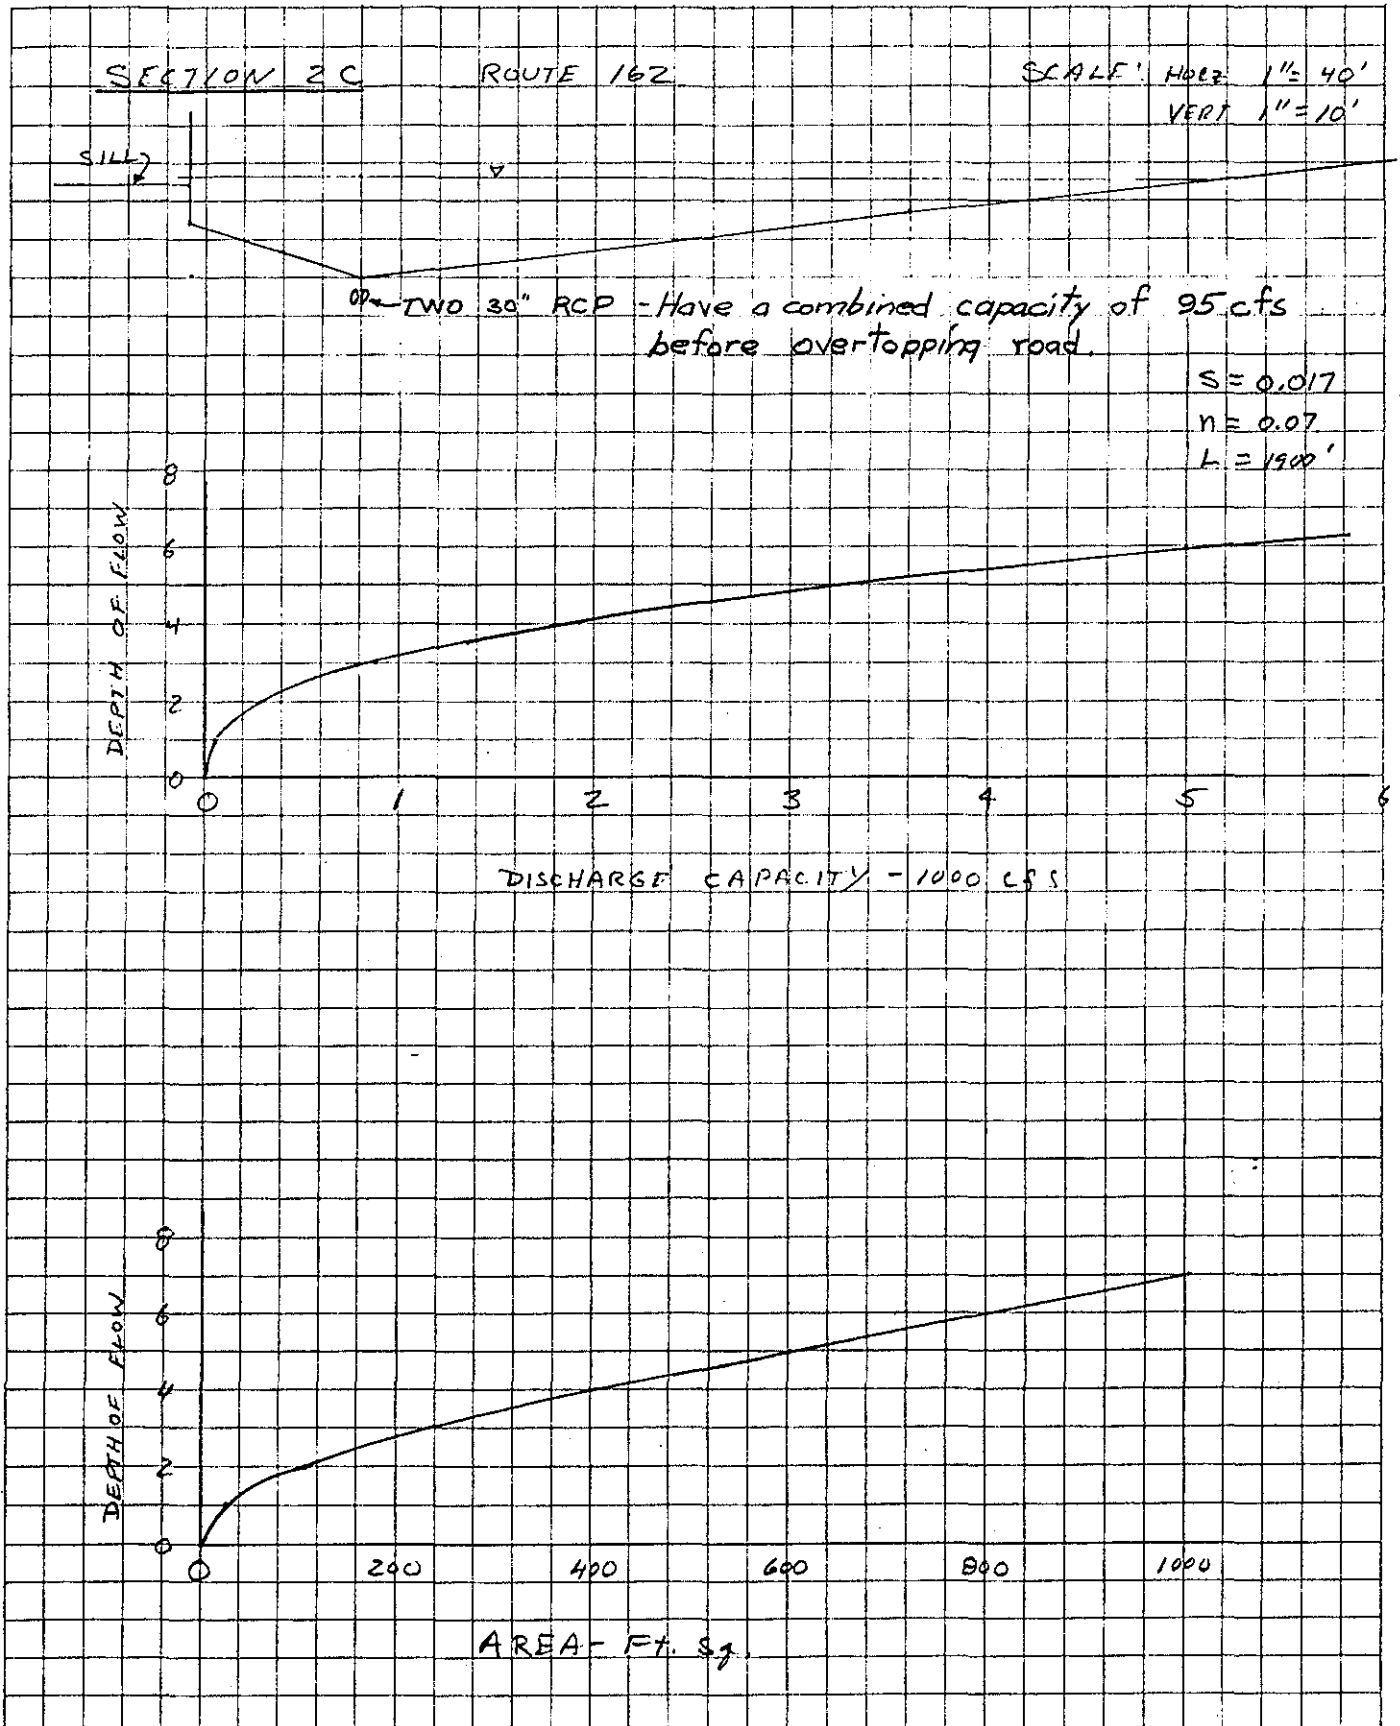
Failure of the dam at the spillway of Upper Lake Phipps would release about 4600 cfs onto and across Main St. Sec. 16. There is a 24-inch pipe and a 36-inch pipe crossing under Main Street, these have an insignificant capacity compared to the dam breach flood, about 80 cfs. The dam breach flood would overtop Main Street by about  $4\frac{1}{2}$  feet and flood several houses to an undetermined depth before returning to the stream channel.

The flood would be about 4,100 cfs at Route 162, Sec. 2C, and would overtop the State Highway by 5.4 feet. Two 30-inch culverts at this point also have a negligible capacity compared to the flood peak, about 95 cfs. The flood waters would inundate 2 houses at Route 162 to about one foot above the sills.

From Route 162 the flood waters would flow within the stream channel and discharge to the tidal marsh without further damage.
